An integrated method for the assessment of the seismic vulnerability of historic buildings

Submitted by Elena Speranza

for the Degree of PhD
of the University of Bath
2003

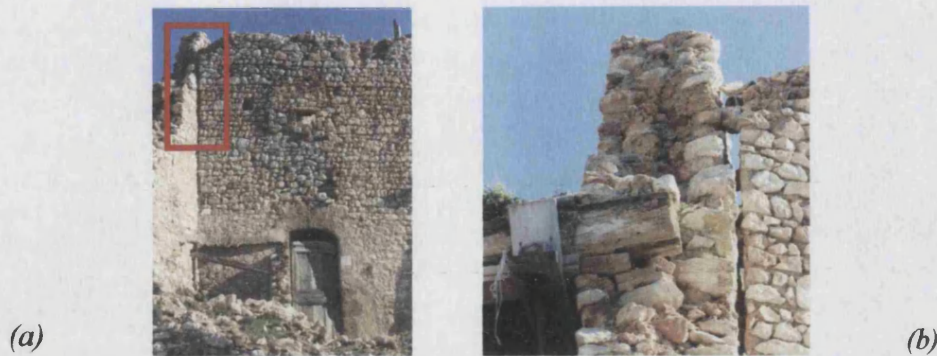
Figure 1- 8 (b) shows an example of orthogonal walls badly connected to each other. It is evident how the total lack of bonds has caused the interface between the two walls to widen during an earthquake.

Figure 1- 8 – Example of two orthogonal walls without connections (Cifo, Italy, 1997)
(a) Global view – (b) Particular

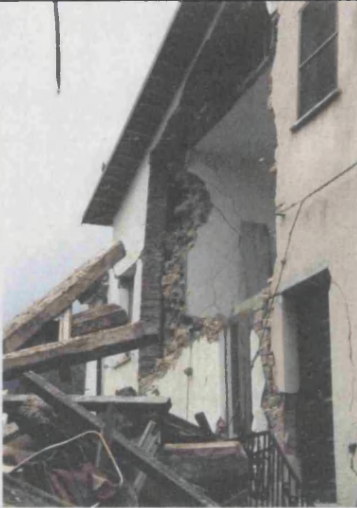
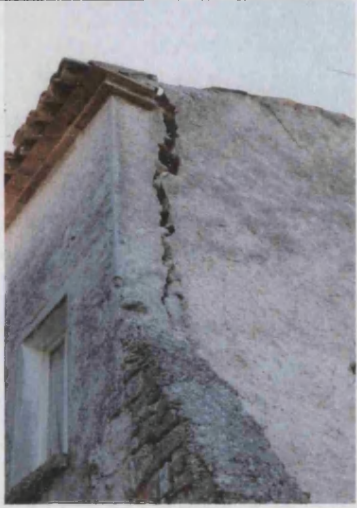
<p><i>Figure 1- 9 – Failure mechanism A: overturning of external wall (a, b) Umbria-Marche, Italy, 1997 (Tampone, 1999)</i></p>
B2

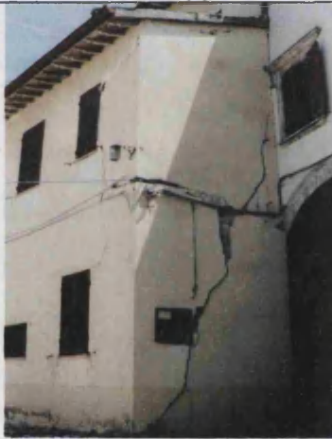
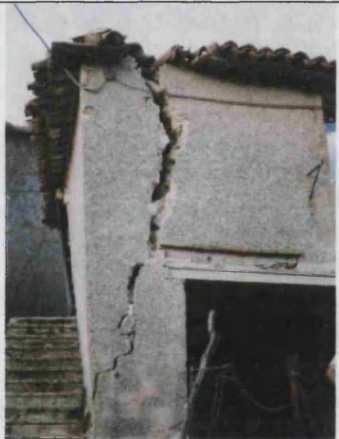
<p><i>Figure 1- 10 – Failure mechanism B2: overturning with participation of both orthogonal walls. (a, b) Umbria-Marche Italy, 1997 (GNDT 1998, Tampone, 1999)</i></p>
B1

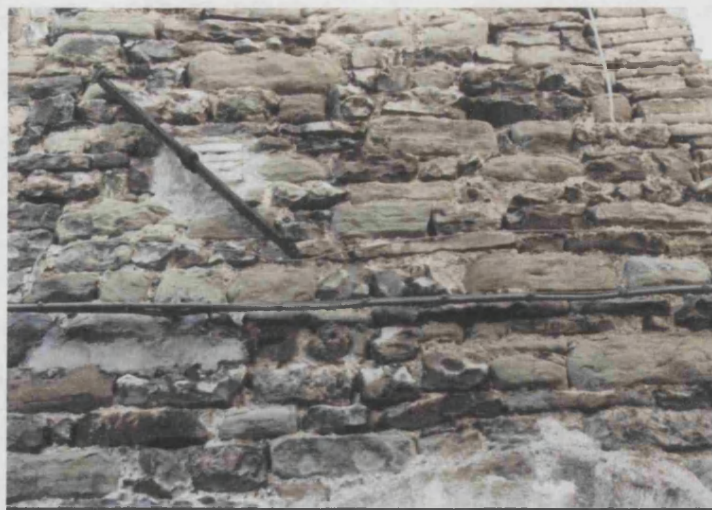
Figure 4- 5 – Metallic anchor on a wall made up of poor material

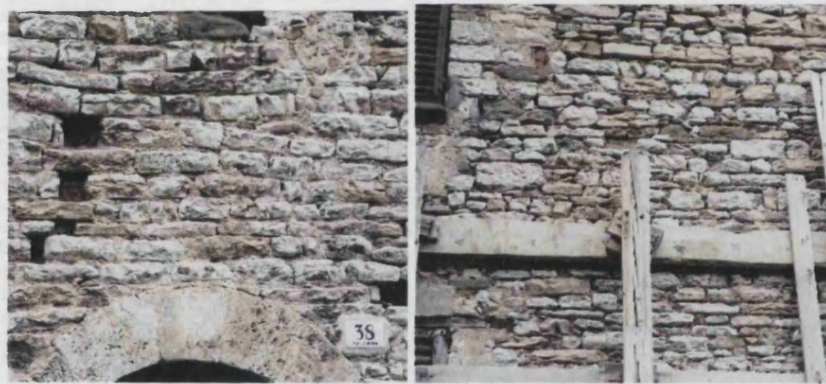
Figure 4- 9 Examples of fabric types A2 (left) and B1 (right)

Figure 4- 9 and Figure 4- 10 show an example of some fabrics A2, B1,C1 and C2 .

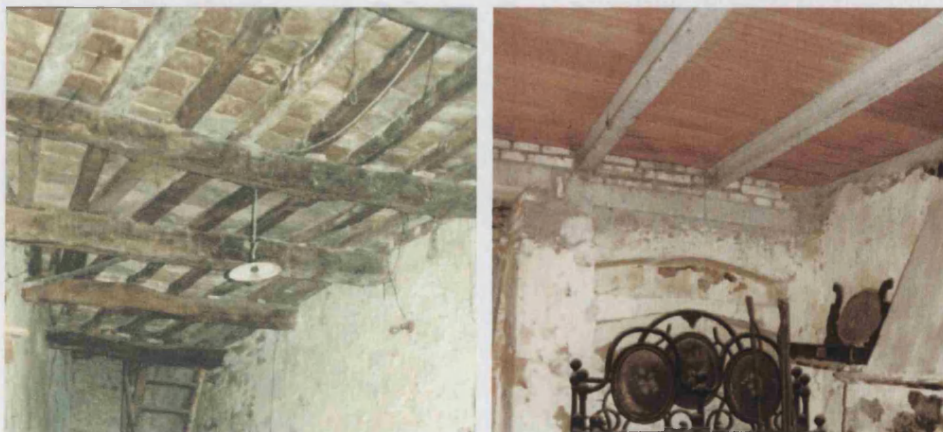
Figure 4- 13 – Examples of horizontal structures of type A (left) and C (right) surveyed in Nocera

- TYPE A: *Timber structures characterised by timber beams supporting secondary purlins covered by tiles or planks.*
- TYPE B: *Timber structures of type A strengthened by metallic mesh within a thin concrete layer, placed over the tiles or planking level. Usually, but not necessarily, the mesh is anchored to the bearing walls.*
- TYPE C: *Precast concrete joists and lightweight tiles. No device is usually employed to anchor the joist edges to the walls.*
- TYPE D: *Reinforced concrete slabs.*

Figure 4- 13 and Figure 4- 14 show an example of structure types A,B and C.

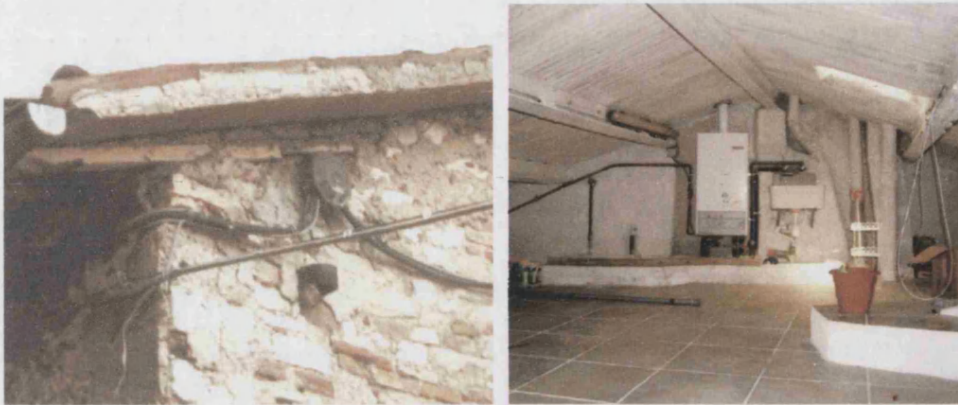
Figure 4- 14 – Examples of roof structures of types B (left) and C (right)

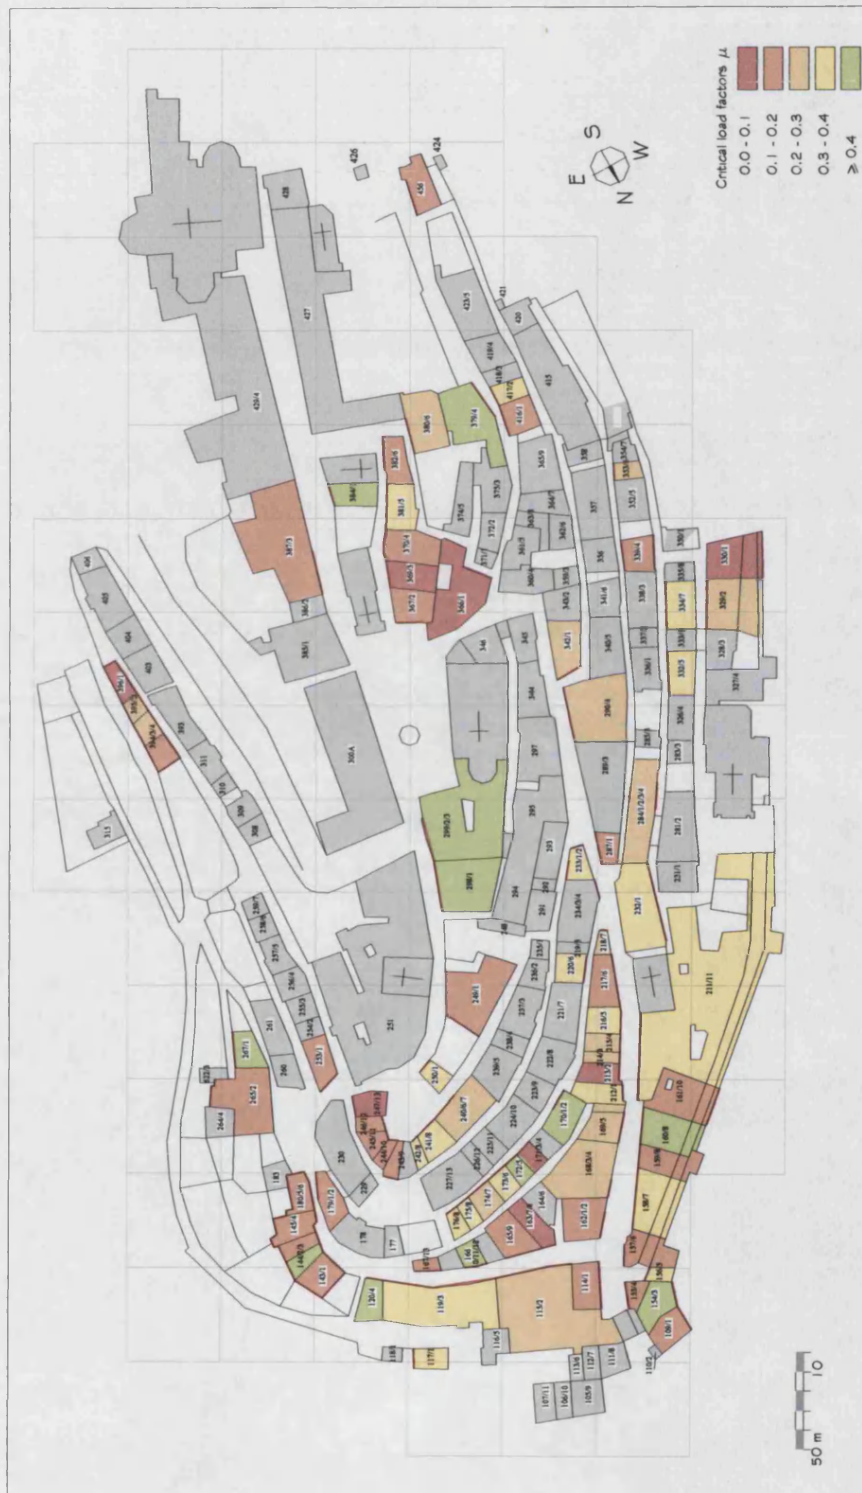
Figure 5- 1 – Distribution of critical load factors μ over the building stock

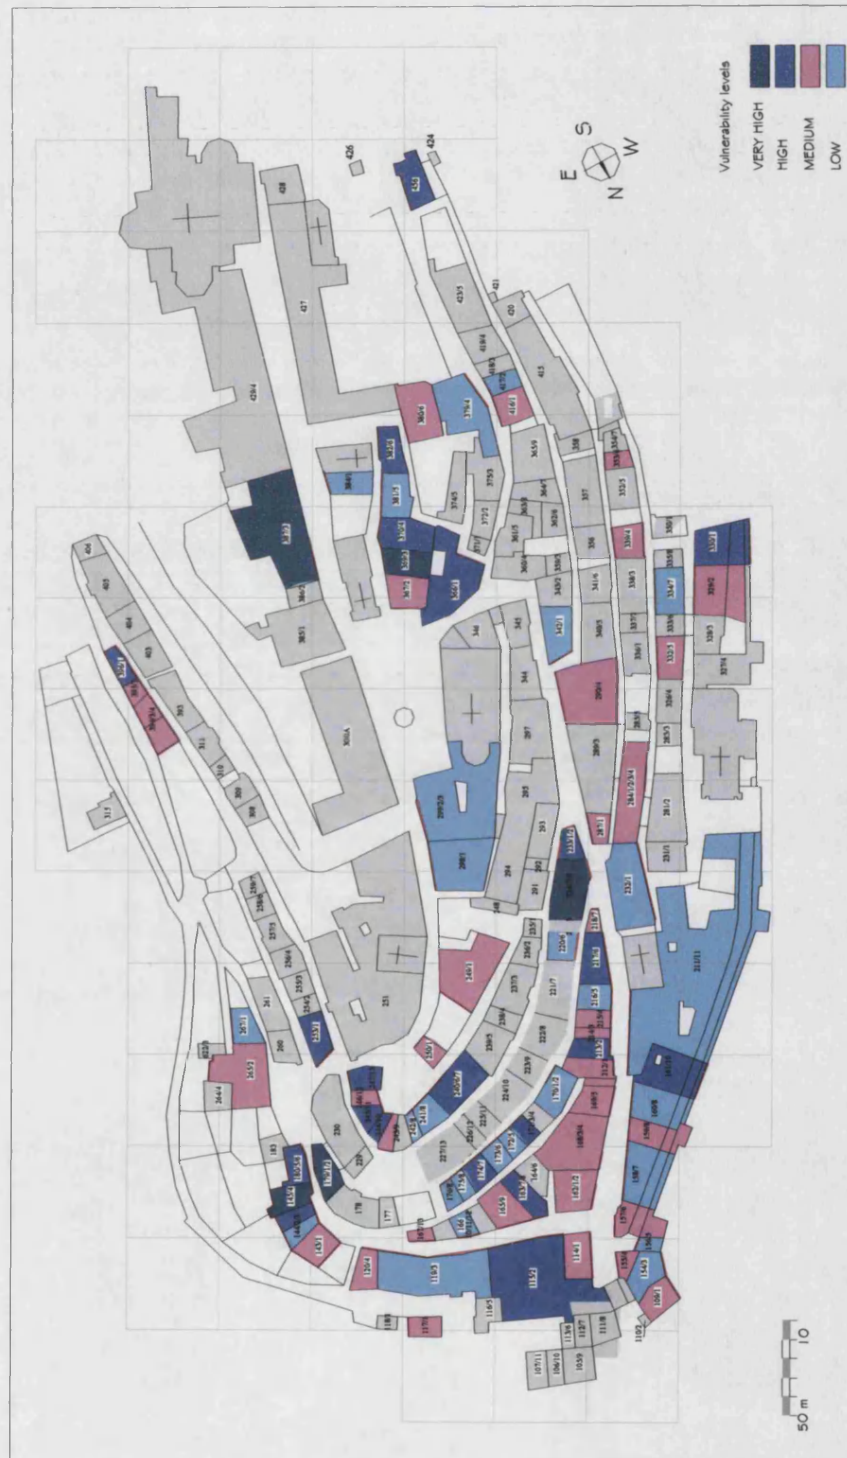
Figure 5- 12 – Distribution of the seismic vulnerability classes over the building sample
